PAVED SHOULDER PROBLEM - STEVENSON EXPRESSWAY

A Phase of
Research Project IHR-6
Condition Survey of Route U.S. 66

July 1967

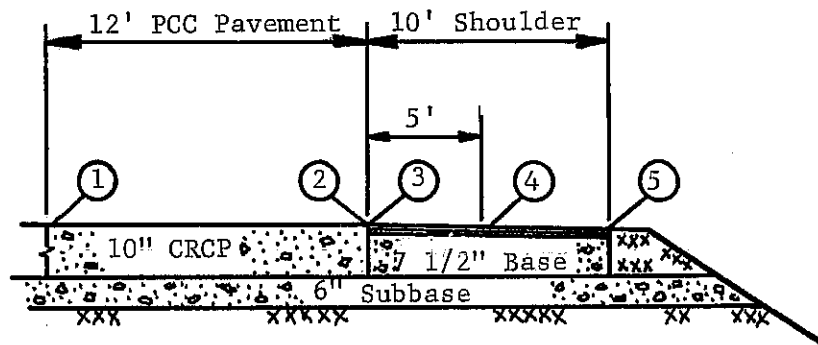
Location of Readings on Typical Cross Section

The daily readings indicate measureable daily fluctuations up to 0.2 inches during the period involved. These minor movements are probably the results of freeze-thaw activity and moisture change in the subgrade and shoulder components. No detailed exploration of the causes was made.

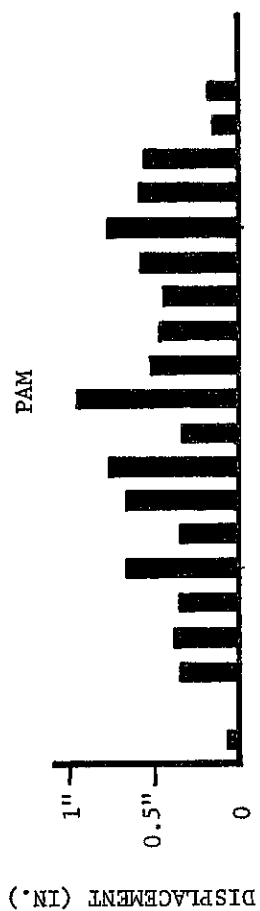
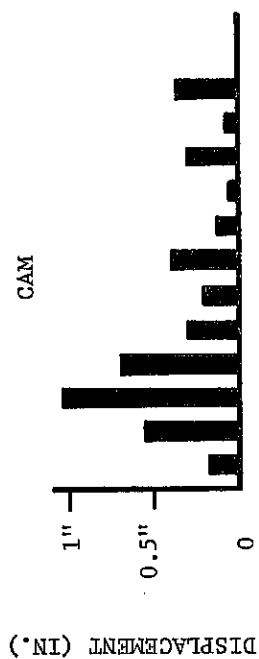
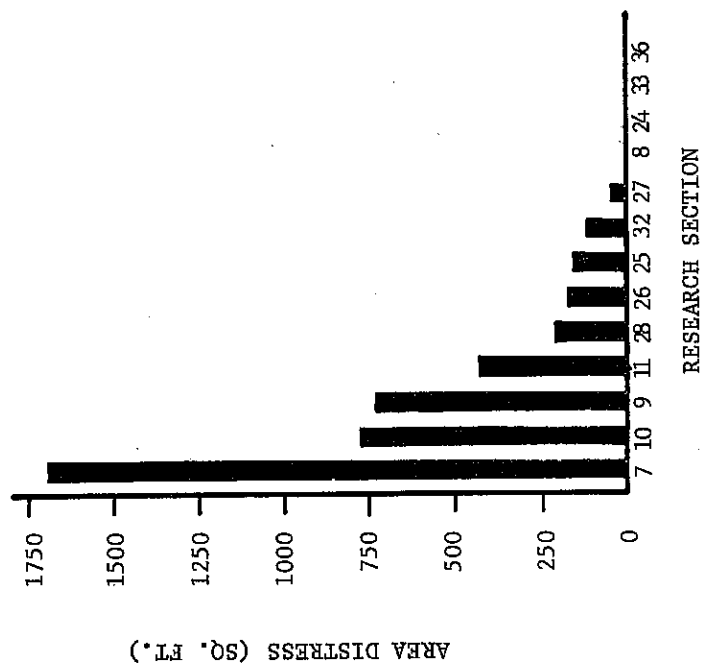
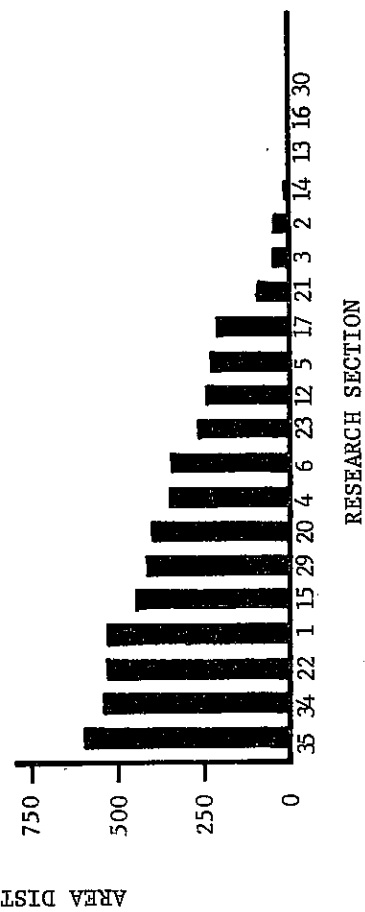
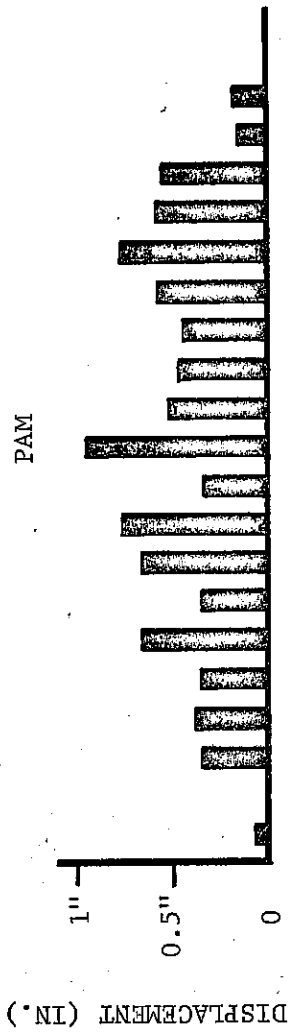
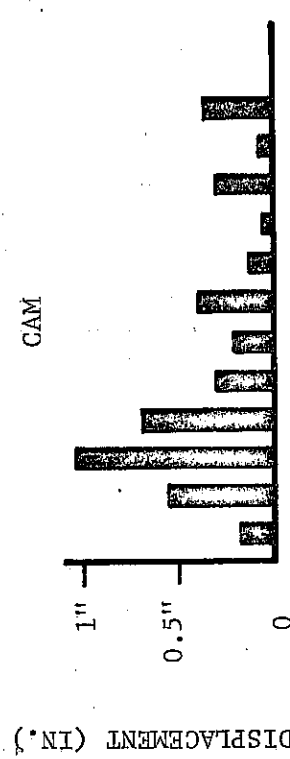
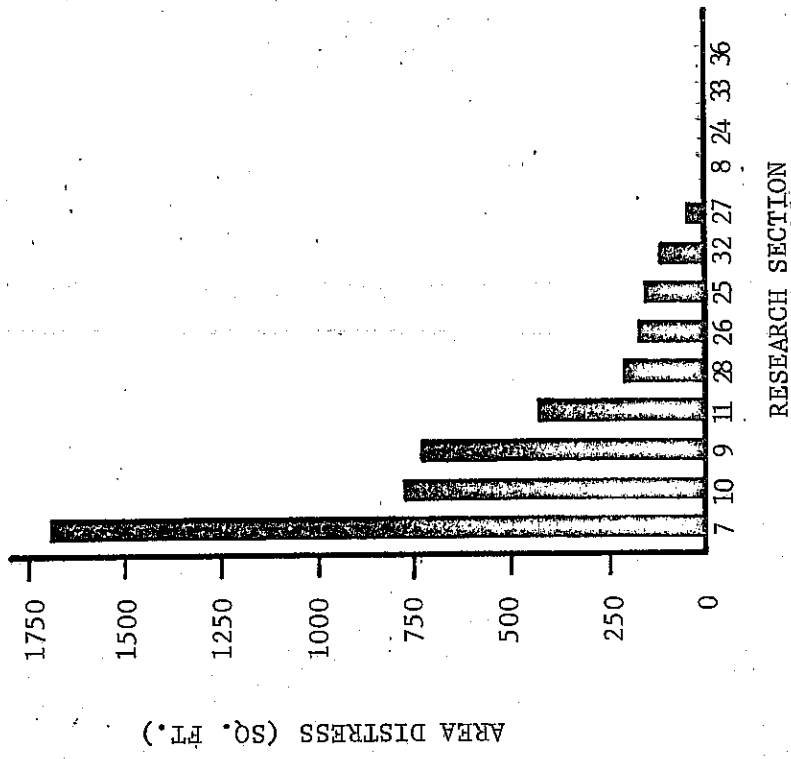
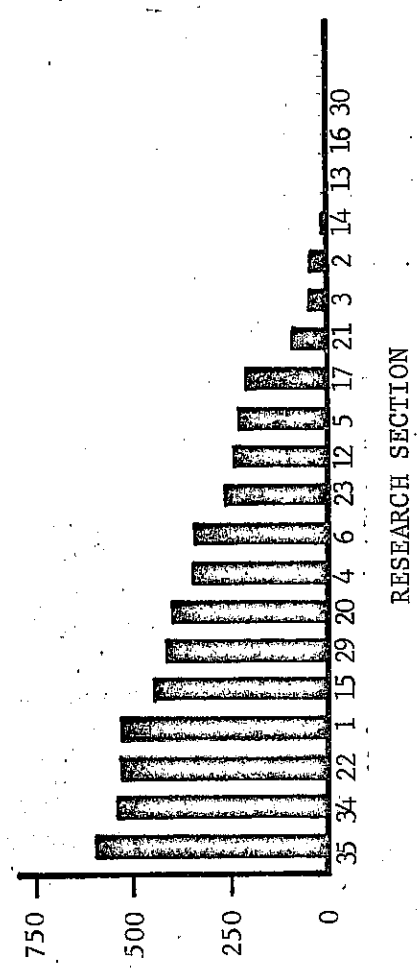
Figure 3. Area distress of paved shoulders as related to vertical displacement.

It seems reasonable to hypothesize that area distress is somehow related to the differential movement of the shoulders with respect to the pavement. Figure 3 has been prepared to assess this relationship, using the vertical movement differentials of the February survey and the areal extent of broken shoulder pavement recorded in the May survey. It will be noted from Figure 3 that the measurements made in the present study did not establish a clear relationship. This analysis was limited to the CAM and PAM shoulder bases for it will be recalled that no distress occurred in the BAM base.

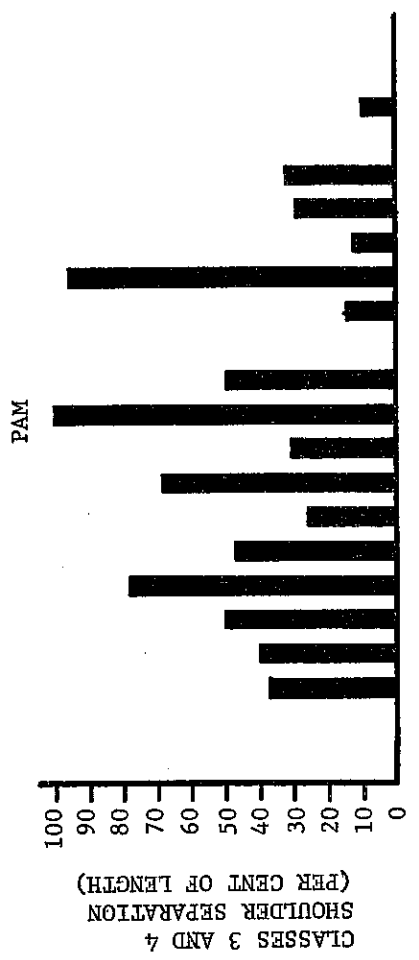
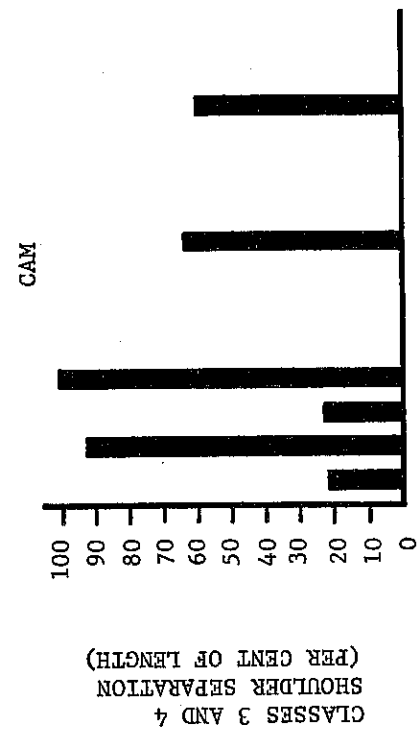
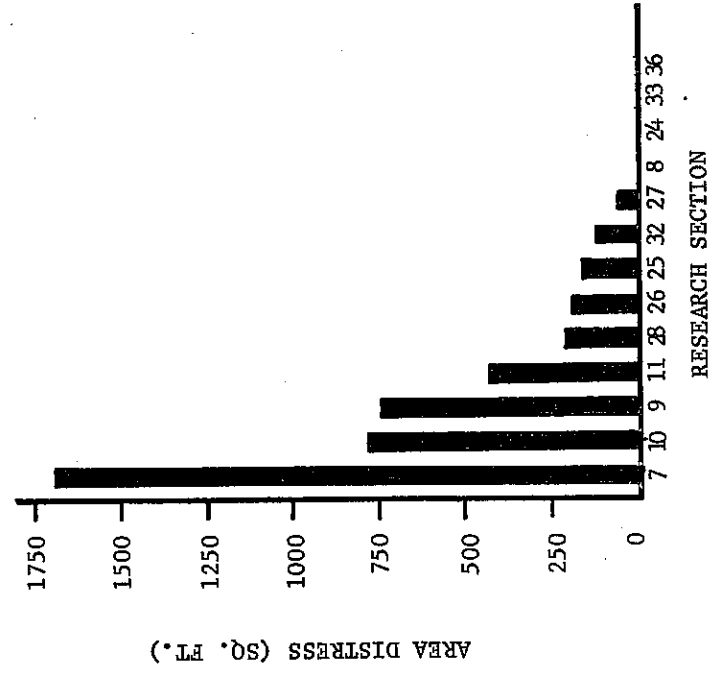
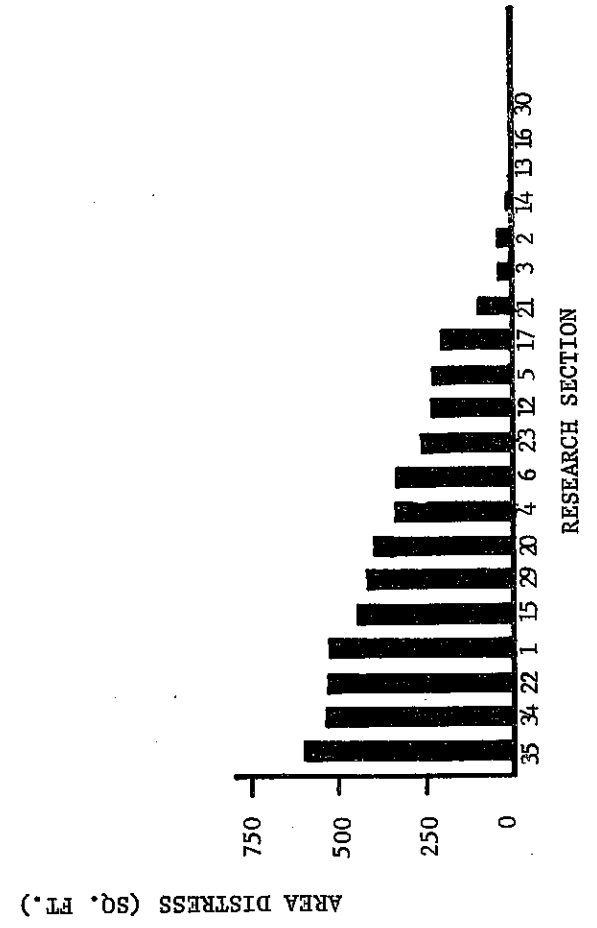
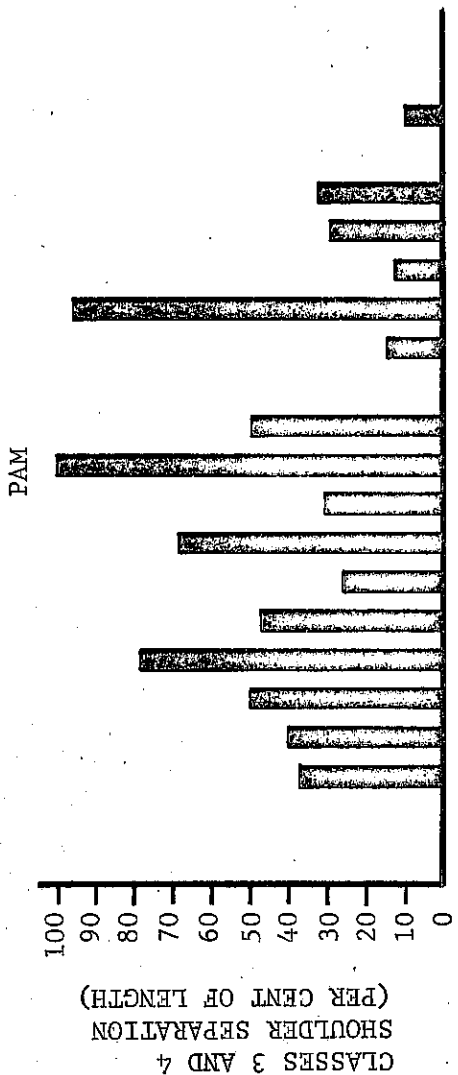
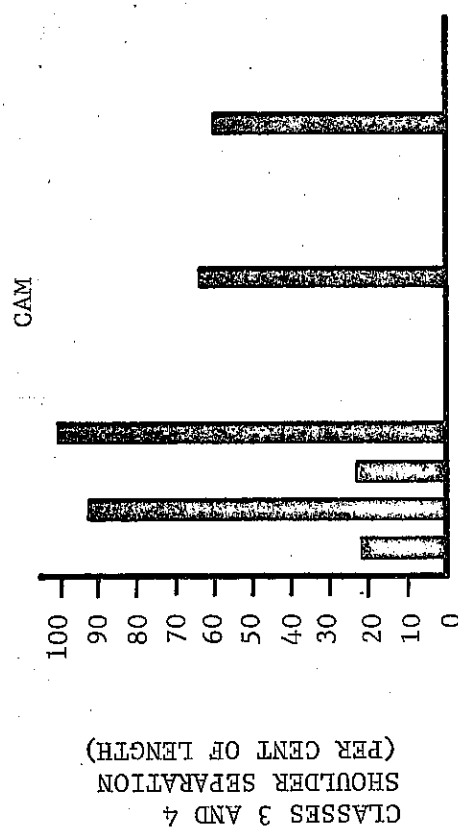
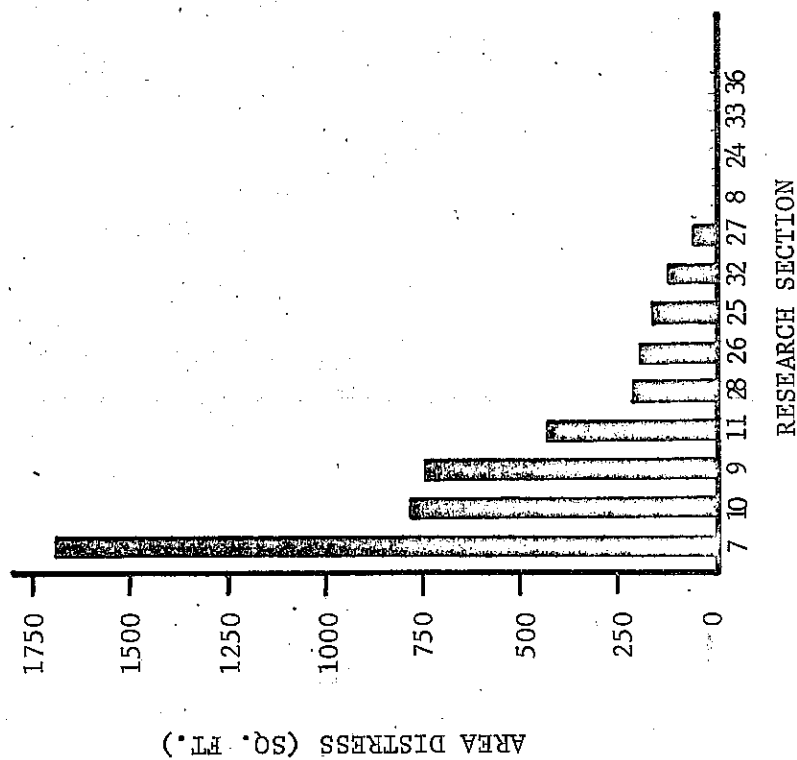
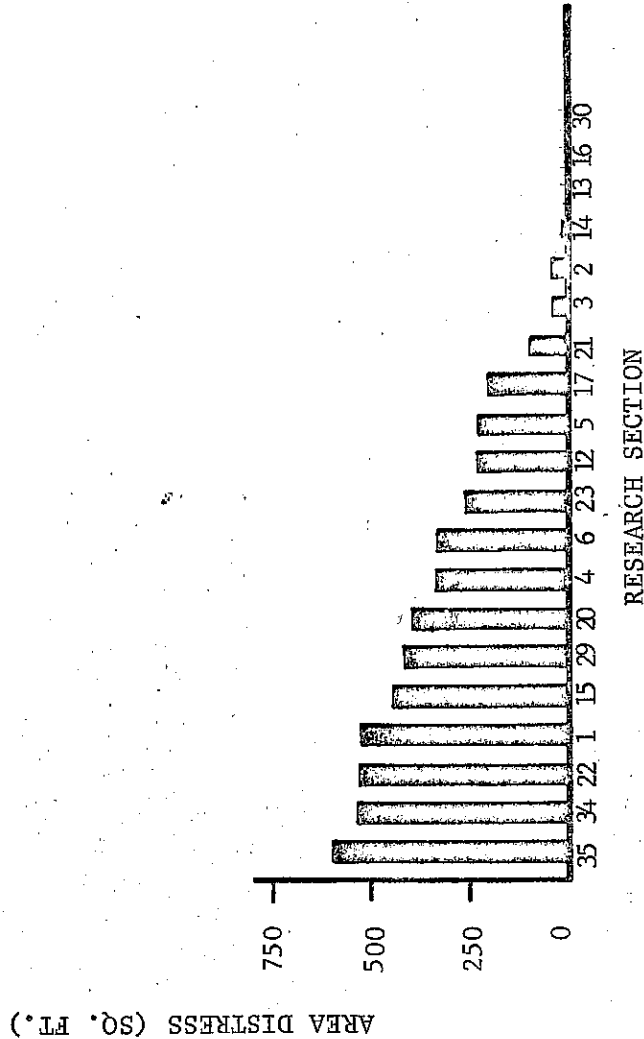
Figure 4. Area distress of paved shoulders as related to shoulder separation.

Figure 4 was prepared to determine whether or not a relationship may exist between the severity of surface distress and the degree of shoulder separation. Figure 5 was prepared to determine whether a relationship exists between the amount of vertical displacement of the shoulders and shoulder separation. It will be noted that no clear relationships could be established from Figures 4 and 5.

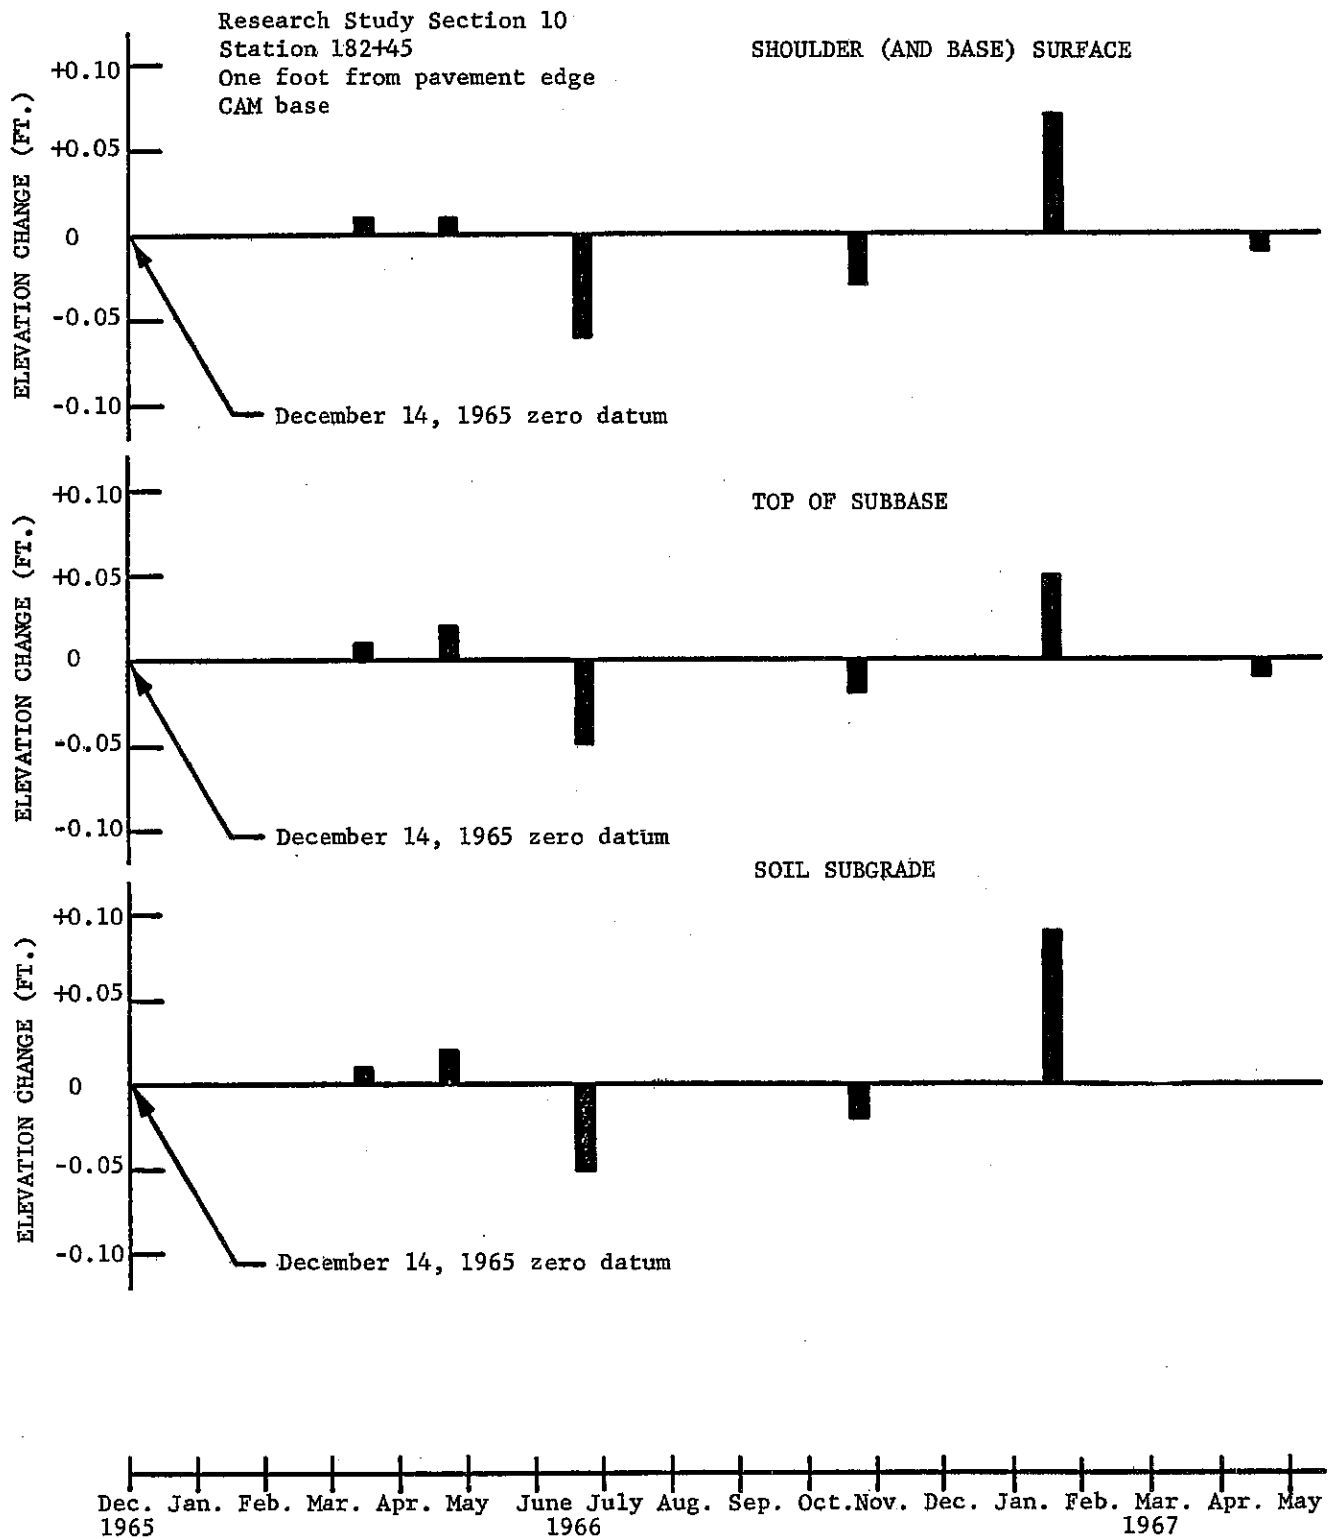
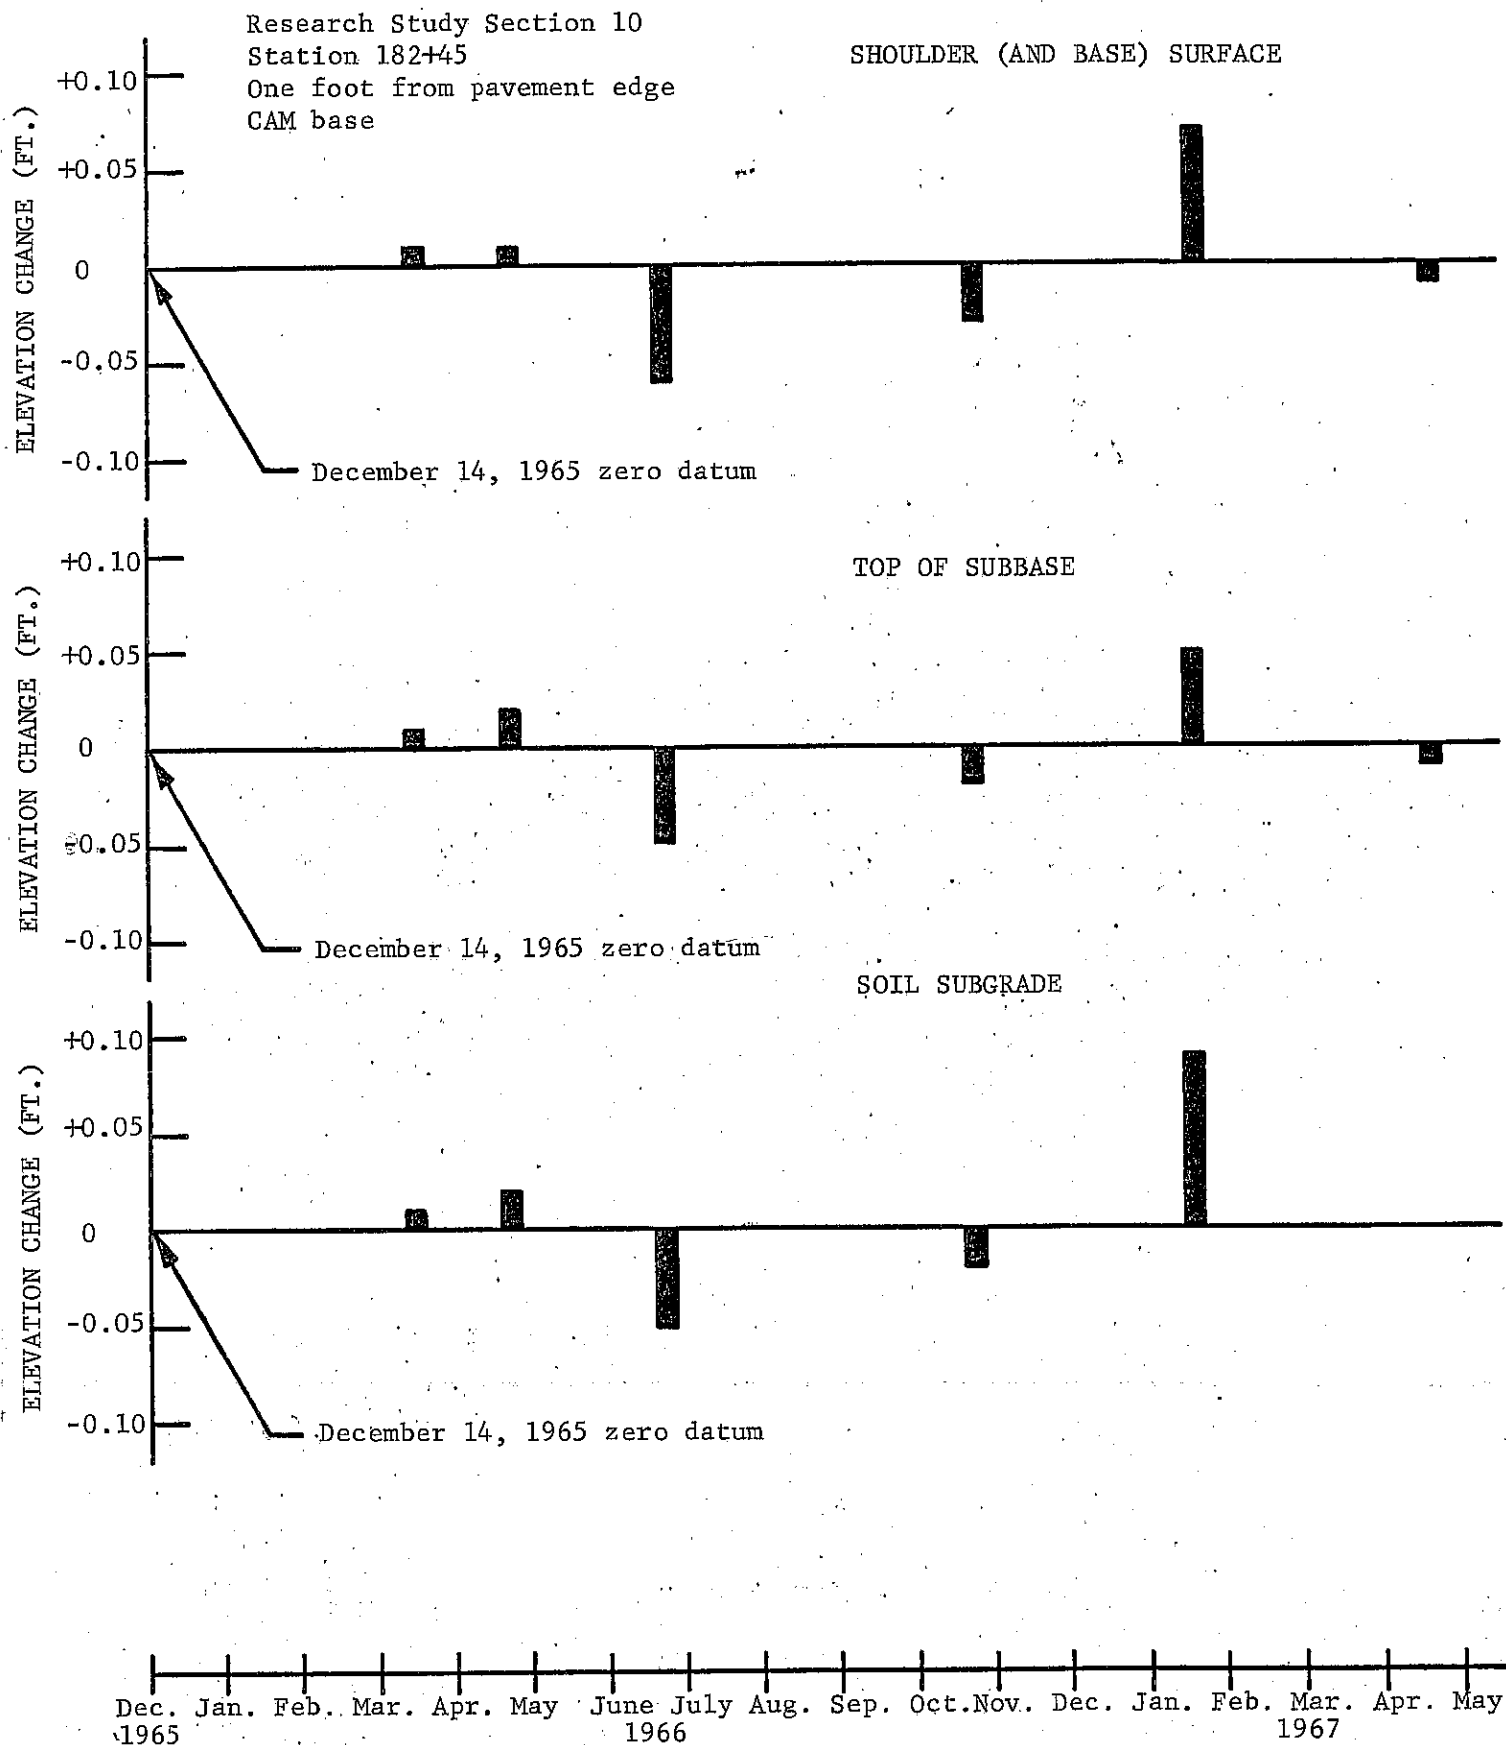
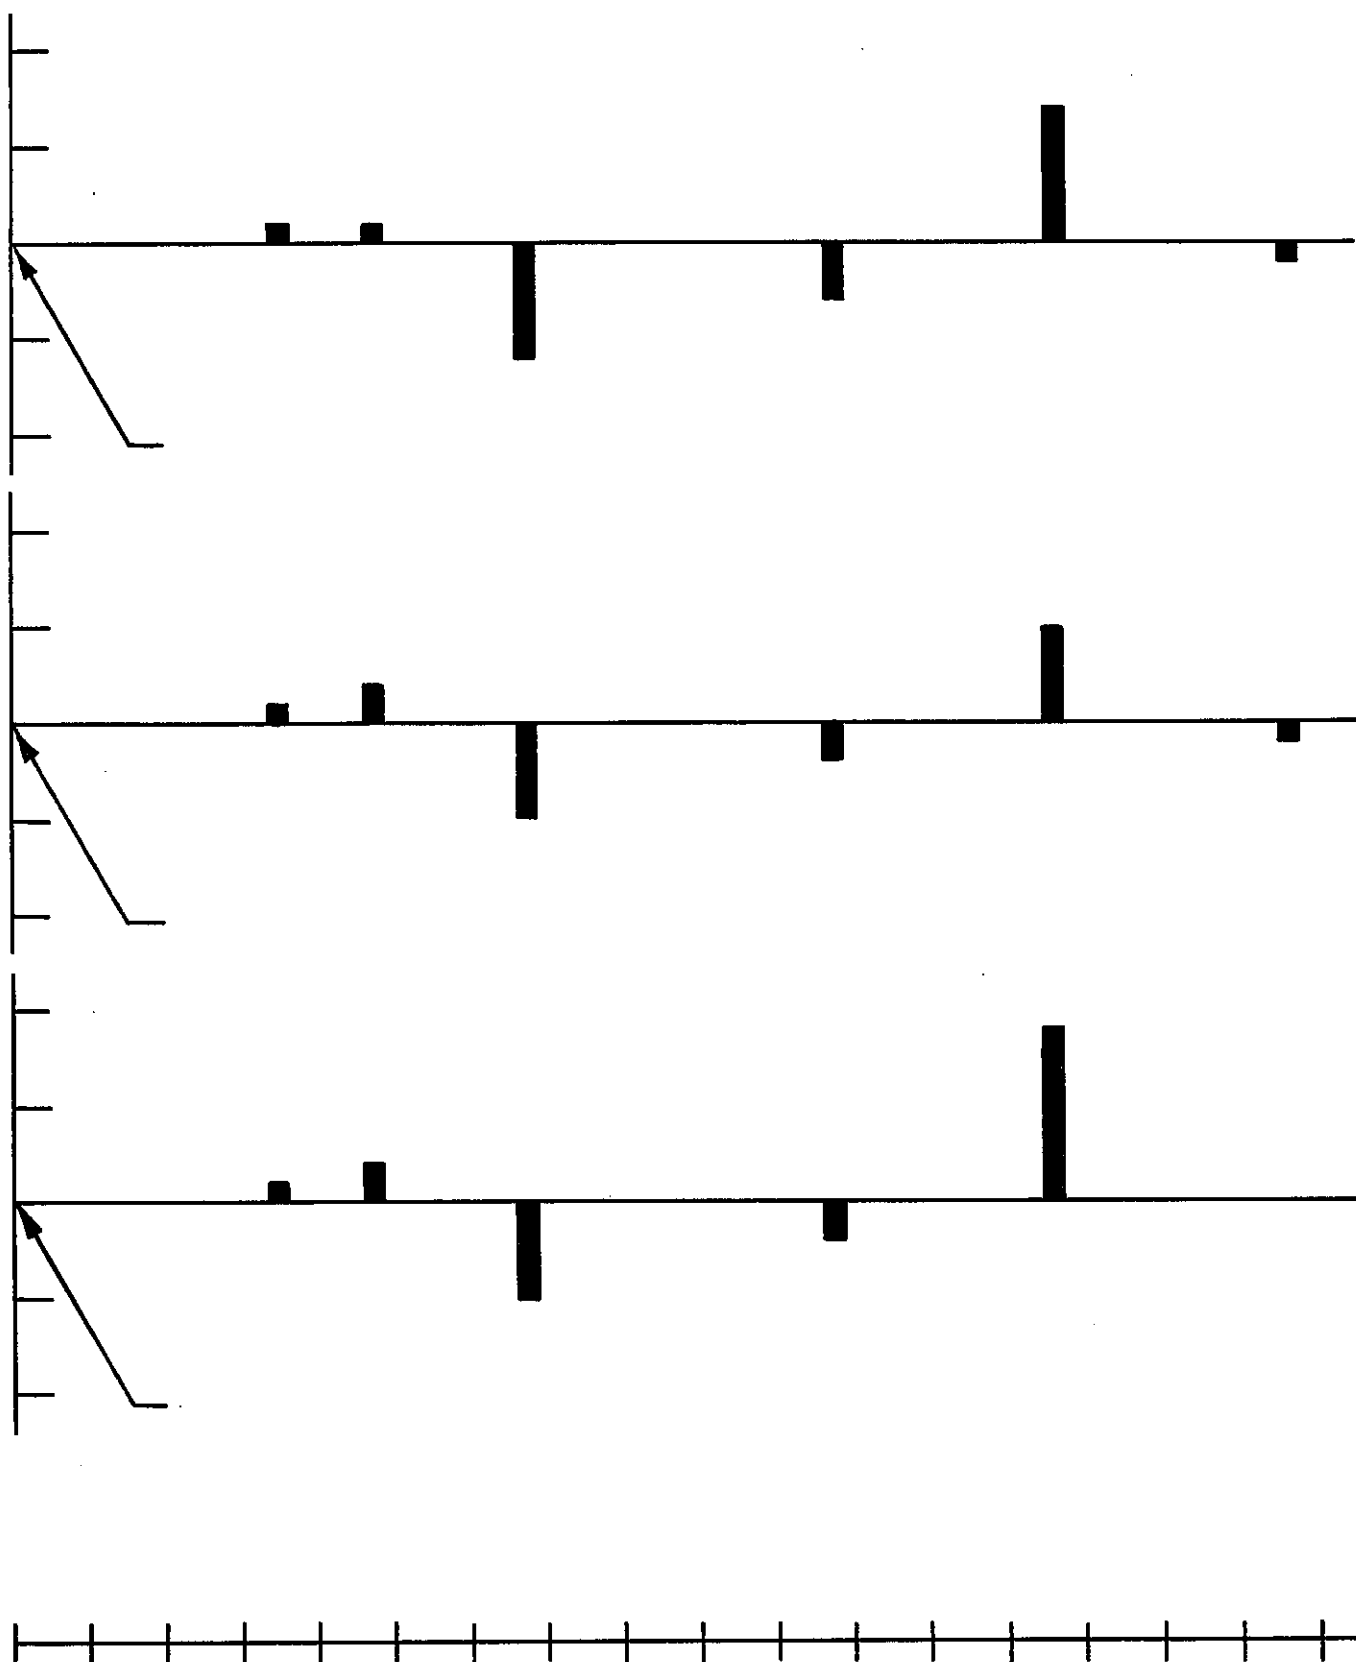
Figure 6. Typical changes in elevation of shoulder components.

The information presented in Figure 6 is typical of the data obtained from periodic elevation readings. For the purpose of evaluation, all readings have been referenced to the initial readings made on December 14, 1965. It will be seen that the shoulder structure and the embankment at subgrade level were subject to vertical upward movements during the winter months and to downward movements during the spring and summer months. From the limited data available, it appears that the subgrade soil has a major influence on the total volumetric change, with the shoulder structure components adding a lesser contribution.

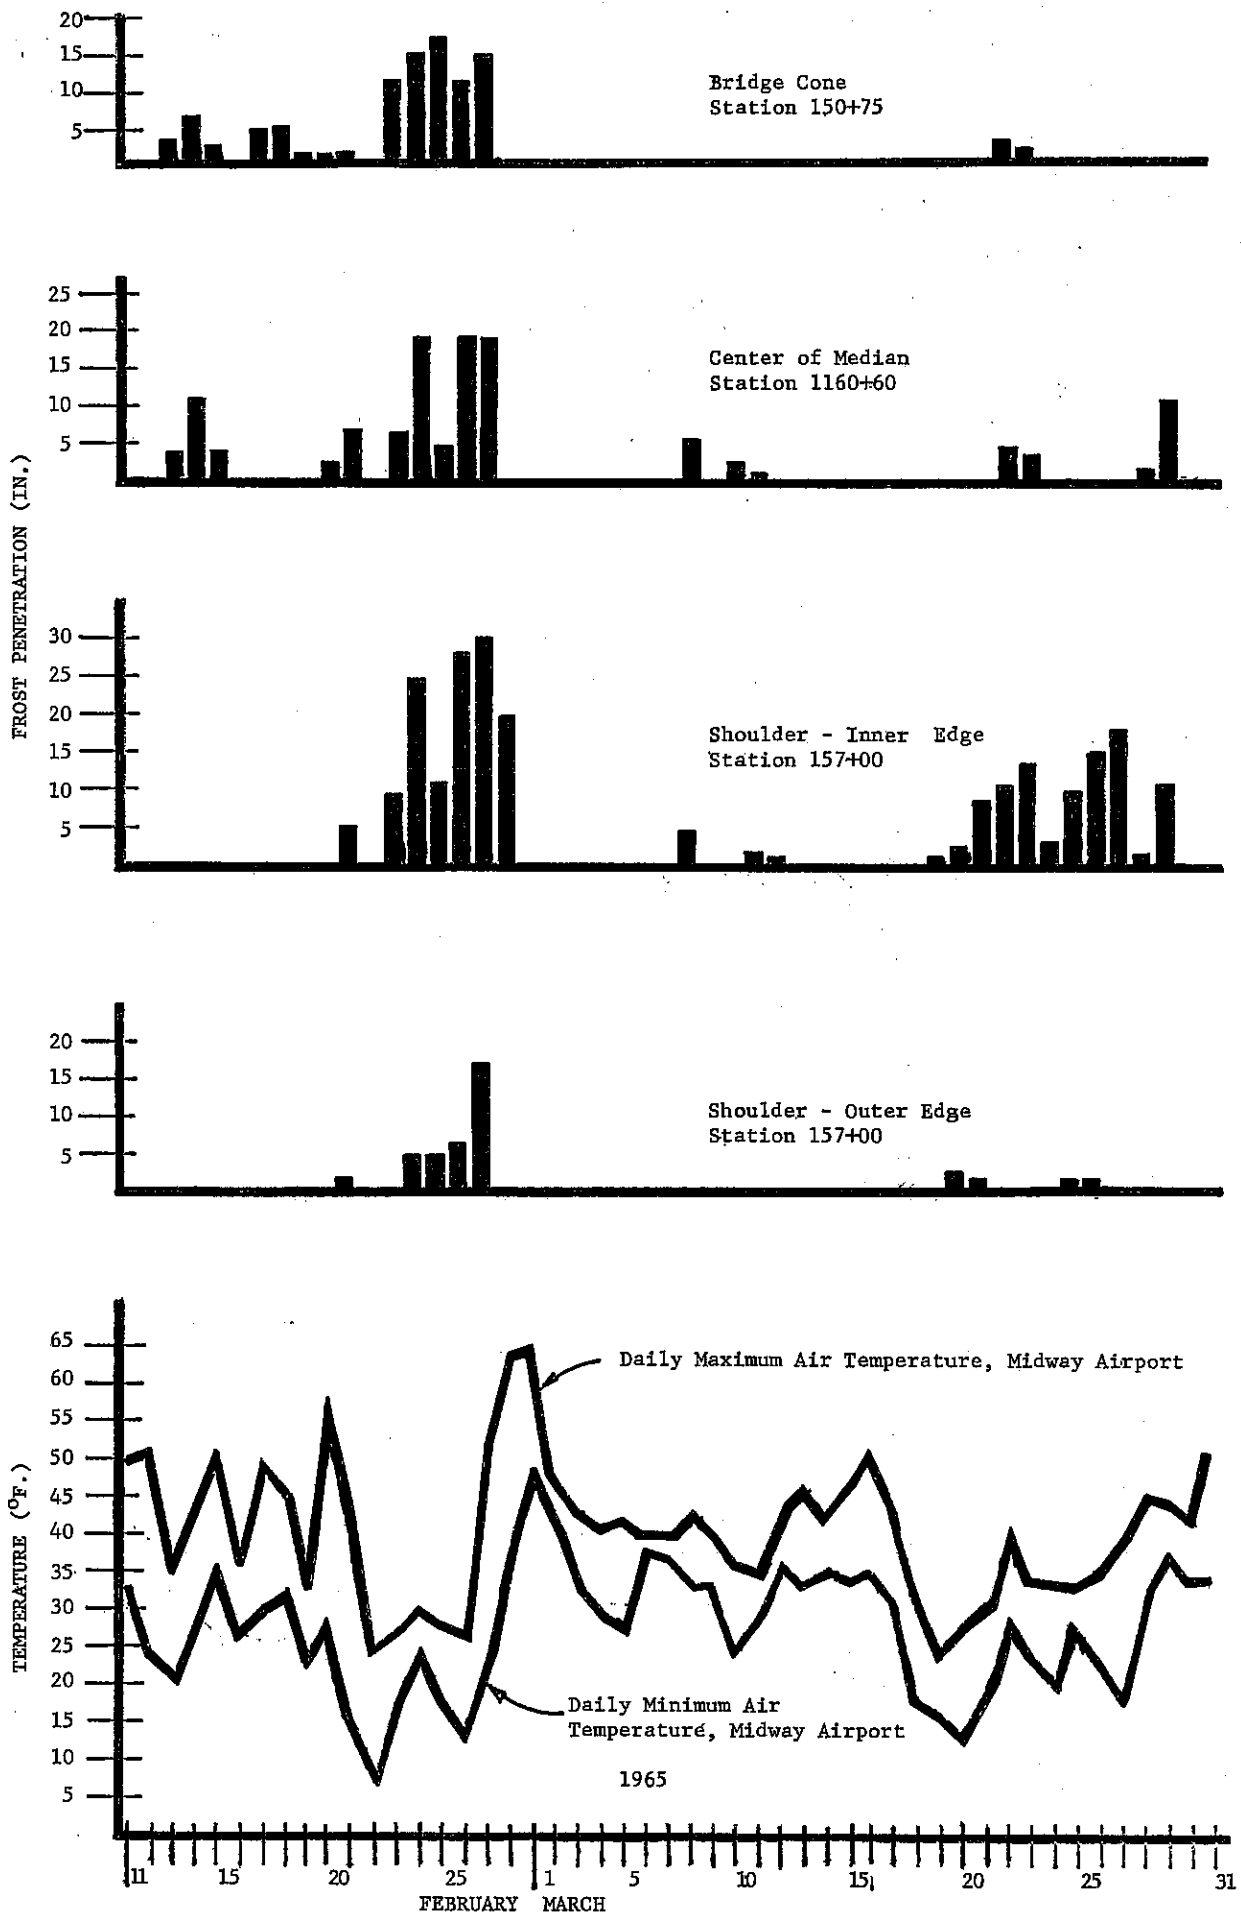
Figure 7. Measured frost penetration

Frost penetration results together with minimum and maximum air temperatures are charted in Figure 7. In general, the readings show a predictable pattern of frost penetration during colder weather. However, individual readings and day-to-day changes are sufficiently erratic to suggest some hesitancy in accepting the results without further testing of the frost meters.
